## **Hot Piston Ring Tests**

David J. Allen  
Sverdrup Technology, Inc.  
Middleburg Heights, Ohio 44130

William A. Tomazic  
National Aeronautics and Space Administration  
Lewis Research Center  
Cleveland, Ohio 44135

Prepared for  
Twenty-fifth Automotive Technology Development  
Contractors' Coordination Meeting  
sponsored by the U.S. Department of Energy  
Dearborn, Michigan, October 26, 1987

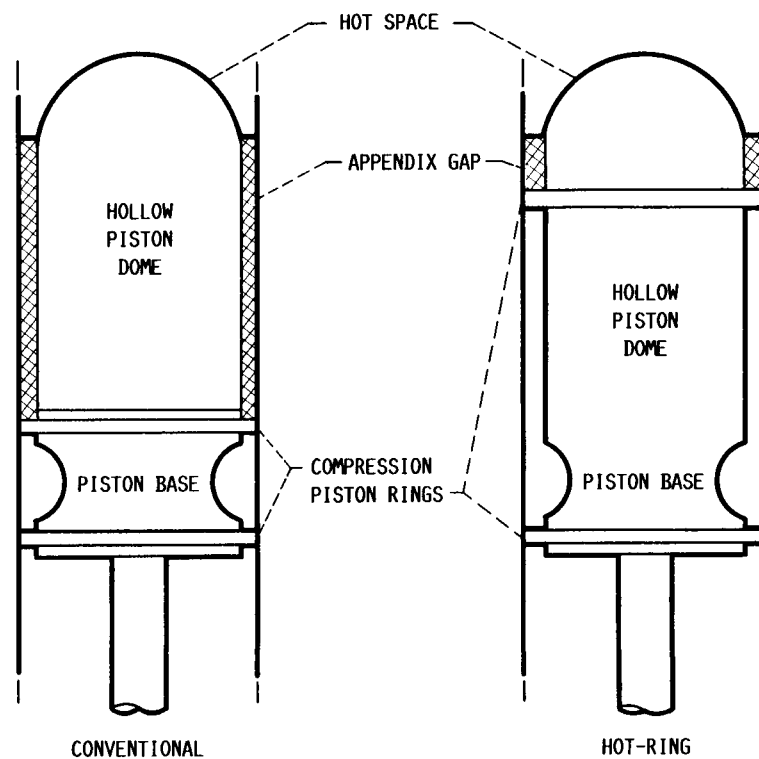
FIGURE 1. - APPENDIX GAP.

Advanced component technology testing was done at NASA Lewis on a Mod I kinematic Stirling engine this past year. This research and development program was initiated in an attempt to reduce the "appendix gap" losses defined analytically for the Stirling engine. The appendix gap is the volume between

the cylinder wall and the actual piston dome itself as shown in figure 1. This volume is the cross-hatched area. These appendix gap losses in theory result in a decrease in engine performance, namely engine brake power and brake efficiency. A possible way to reduce this appendix gap loss is to install an additional piston ring at the top of the piston dome to eliminate or reduce working gas flow in and out of the appendix gap. The conventional piston configuration is shown at the left of figure 1 with the hot-ring modified version at the right. This cannot be done with the standard Rulon ring because of the extremely harsh environment that this ring must withstand in this region. The operating temperature in this region is approximately 700 °C (1292 °F) with a hydrogen atmosphere. A high temperature metal alloy is needed to survive under these conditions. Stellite 6B was used for these tests. Some form of lubrication is also required to allow adequate friction and wear resistance for this hot-ring. A high temperature dry lubricant developed at NASA Lewis was adapted for this purpose.

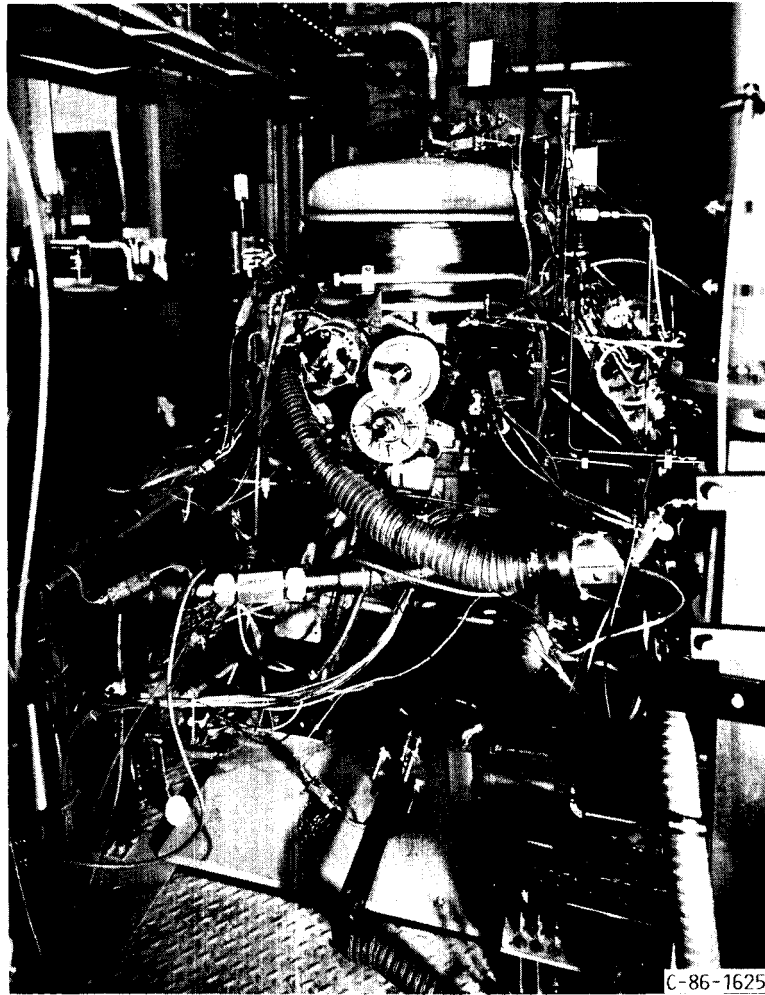
FIGURE 2. - ENGINE IN TEST CELL.

The engine used for this testing was a Mod I Automotive Stirling Engine with the auxiliaries, except for the oil pump and hydrogen compressor, removed. Figure 2 is a photograph showing the engine in the test cell on the test stand. The lines running throughout the photo were for research instrumentation.

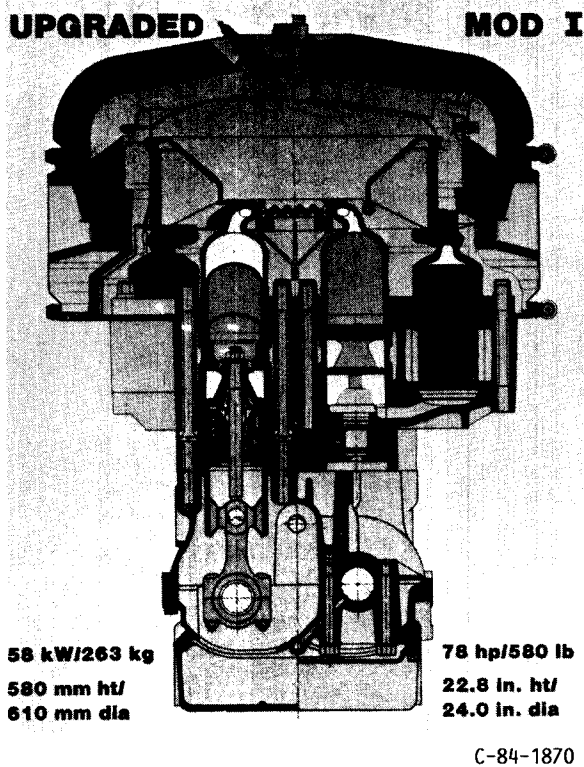
FIGURE 3. - MOD I AUTOMOTIVE STIRLING ENGINE.

Figure 3 is a schematic of the engine. The reason for introducing this schematic is to show where the modified components are located with respect to the rest of the engine components. Modified piston domes were attached to the standard piston bases and modified cylinder heads were installed in place of the original cylinder heads.

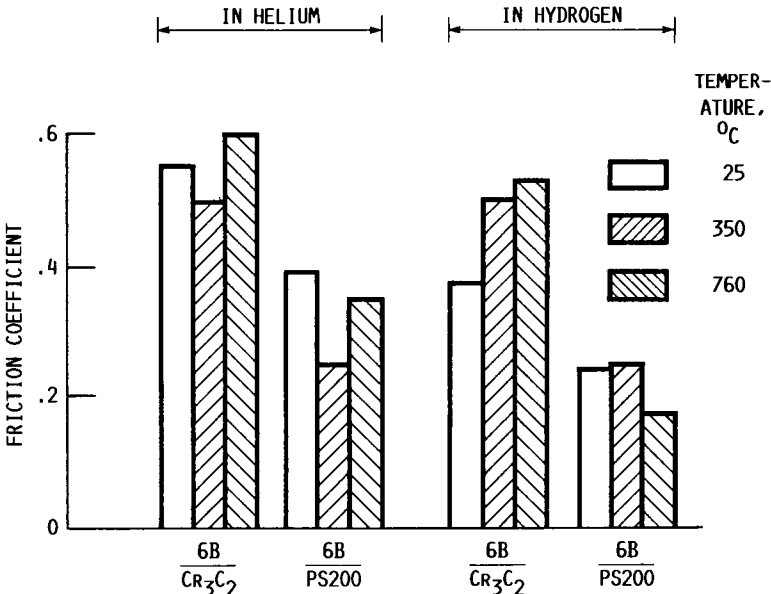
FRICTION OF STELLITE 6B SLIDING ON BONDED CHROMIUM CARBIDE  
AND ON PS200

FIGURE 4. - BONDED CHROMIUM CARBIDE AND PS 200 IN STIRLING ENGINE  
ATMOSPHERES.

As mentioned previously, some form of dry high temperature lubricant was required to allow operation of the hot-ring in the high temperature cylinder environment. A material developed at NASA Lewis (PS-200) looked promising. PS-200 has a base of 48 percent chrome carbide and 32 percent nickel aluminide with 10 percent calcium and barium fluoride eutectic, and 10 percent silver. The chrome carbide-nickel aluminide provides the wear resistance, while the eutectic-silver mix provides the high temperature lubricant. Pin-on-disk wear and friction tests were made in both helium and hydrogen at temperatures up to 760 °C (refs. 1 and 2). Several potential ring materials were tried initially before the Stellite 6B was selected. Figure 4 shows the results of these tests. PS-200 shows a significant reduction in friction coefficient over the chrome carbide--from 0.6 to less than 0.2. Wear rates were low. These tests gave us confidence that we could run the hot-ring equipped engine stably for a long enough time to provide the data necessary for performance comparison.

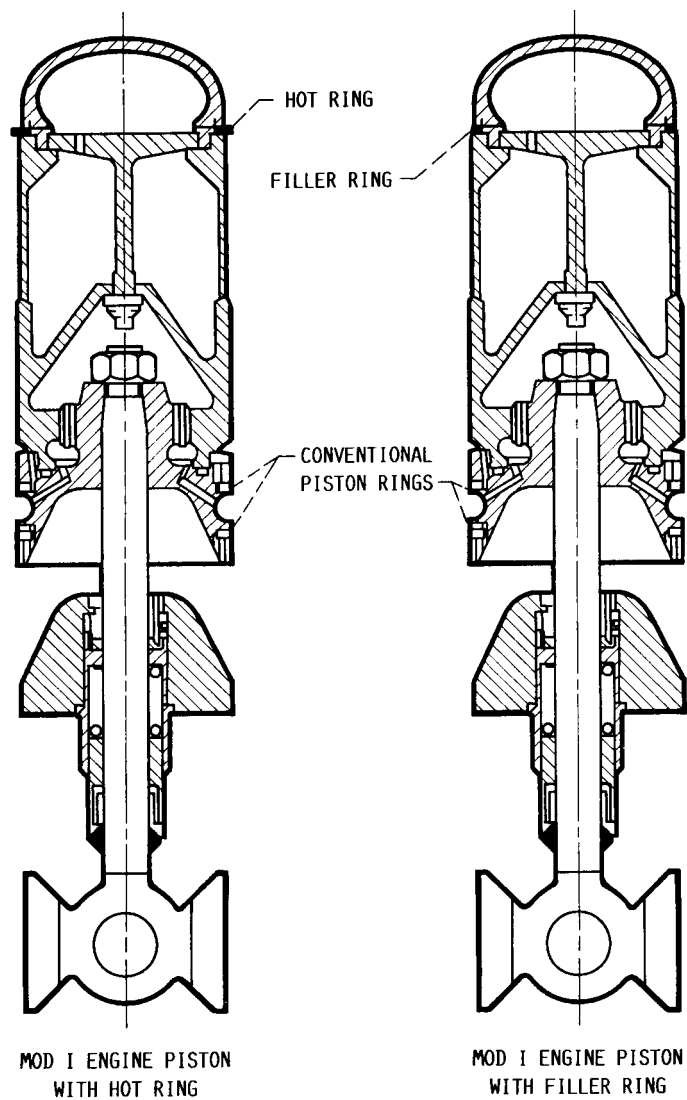
FIGURE 5. - PISTON CONFIGURATIONS. CD-87-29787

The piston ring configurations shown in figure 5 were used for comparison purposes during the engine testing. The hot-ring configuration on the left side was designed by Dr. Roy Howarth of MTI. This consisted of an upper and a lower half to the piston dome which allowed for the removal or replacement of

the additional piston ring. The actual design of the hot-ring configuration included an upper wave spring to keep the hot-ring seated against the lower half of the piston ring groove, an expander ring behind the hot-ring to apply uniform pressure against the cylinder bore, and the hot-ring itself. Standard split-solid Rulon rings were used in the conventional piston ring base grooves. Note the vent holes in the piston base which allowed for manifolding of the minimum cycle pressures in each of the four cylinders. The configuration on the right is a schematic of the baseline piston dome configuration employed for the purpose of comparison. A filler ring was mounted in place of the hot-ring to allow for a uniform transition between the upper and lower half of the piston dome.

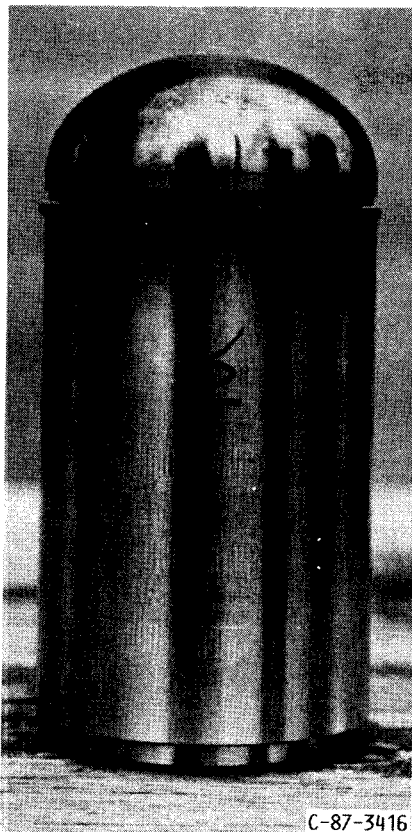
FIGURE 6. - HOT-RING PISTON.

Figure 6 is a photograph of the piston dome in the hot-ring configuration after approximately 22.4 hours of testing. There is significantly less discoloration associated with this hot-ring configuration than with the conventional arrangement. This apparent thermal dam effect will be discussed later.

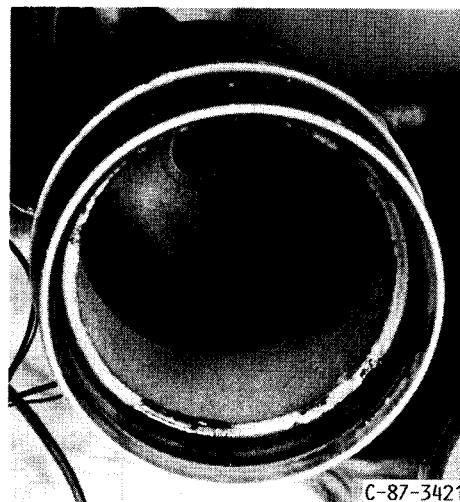
FIGURE 7. - COATED CYLINDER AFTER 22.4 HOURS  
OF OPERATION WITH HOT-RINGS.

Figure 7 is a photograph of a high temperature dry lubricant coated cylinder. As you can see, the darker portion of the photo is where the additional piston ring rode along the stroke of the bore and wore in the coating. The lighter portion is the original diamond-ground, flame sprayed PS-200 coating surface. This coating was flame sprayed and then ground to the particular specifications needed to meet design requirements. Actual measurements from inspection showed that there was only about 0.0002 in. wear associated due to the ring-on-coating contact after 22.4 hours of testing. The surface finish measurement for the as-ground coating was 80  $\mu$ -in. RMS. After wear-in, the surface finish was a very smooth 5  $\mu$ -in. It would appear that almost half the apparent wear was simply reduction of the original surface asperities. It is not clear whether the actual steady-state wear rates would be acceptable for real engine use. However, our purpose was well served.

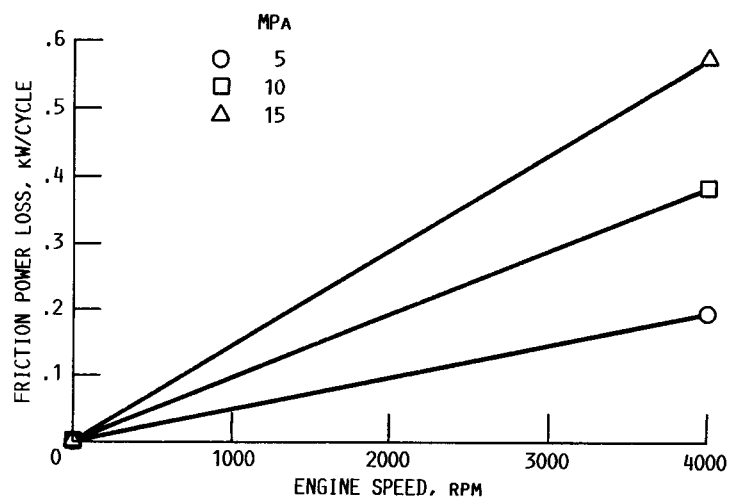
FIGURE 8. - HOT-RING FRICTION LOSS (CALCULATED).

It was necessary to account in some way for the added friction of the hot-ring in order to assess what actual thermodynamic benefit may have resulted. Ring bearing pressures were calculated based on assumed pressure differences across the ring over the cycle. These were integrated along with the piston speed to provide an average value of PV for each operating pressure and engine speed. The total ring surface area was assumed to be the friction bearing surface used in the friction loss calculations. Figure 8 shows friction power loss in kW/cycle as a function of engine speed. At the full-power point of 15 MPa working pressure and 4000 rpm, the total engine loss associated with the hot-ring friction is approximately 2.5 kW and decreases linearly with speed to zero.

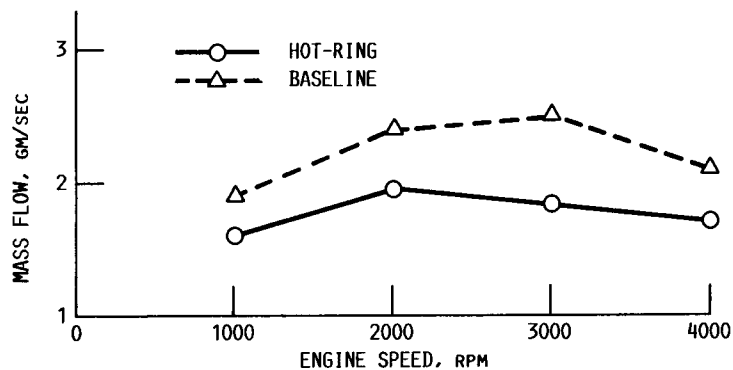
MOD I STIRLING ENGINE; 5 MPa MEAN PRESSURE

FIGURE 9. - SEAL LEAKAGE COMPARISON.

The total working gas leakage past the piston rings was manifolded together (as mentioned previously) and measured in an attempt to gauge the sealing effectiveness of the hot-rings. Leakage normally occurs up across the bottom ring as well as down across the top ring. The hot-ring, of course, is intended to restrict only the flow from the top down. The lower ring is expected to leak similarly in either configuration. A reduction in overall

leakage implies a substantially greater reduction in the flow from the top only. Figure 9 shows a comparison of the leakage between the baseline and hot-ring configurations at 5 MPa operating pressure. A significant reduction is seen. This implies that the hot-ring seals very well and does prevent flow in and out of the appendix gap. Similar results were obtained at 10 and 15 MPa.

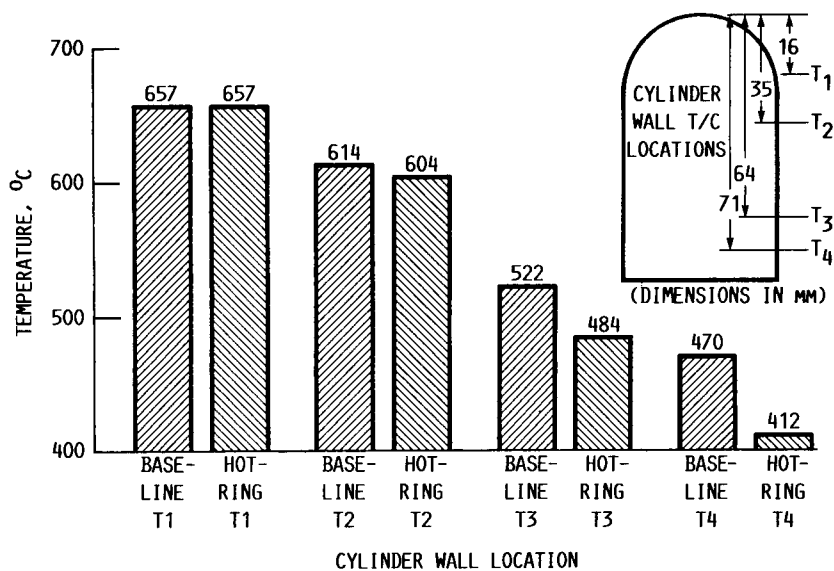
MOD I STIRLING ENGINE; 5 MPa MEAN PRESSURE; 1000 RPM

FIGURE 10. - CYLINDER WALL TEMPERATURE COMPARISON.

A further corroboration of the sealing effect was obtained by measuring the cylinder external wall temperatures. Figure 10 shows typical results of these measurements. These data were taken at 5 MPa and 1000 rpm. The cylinder schematic shows the thermocouple locations. Temperatures for the hot-ring configuration are consistently lower down the cylinder indicating less hot gas flow into the appendix gap.

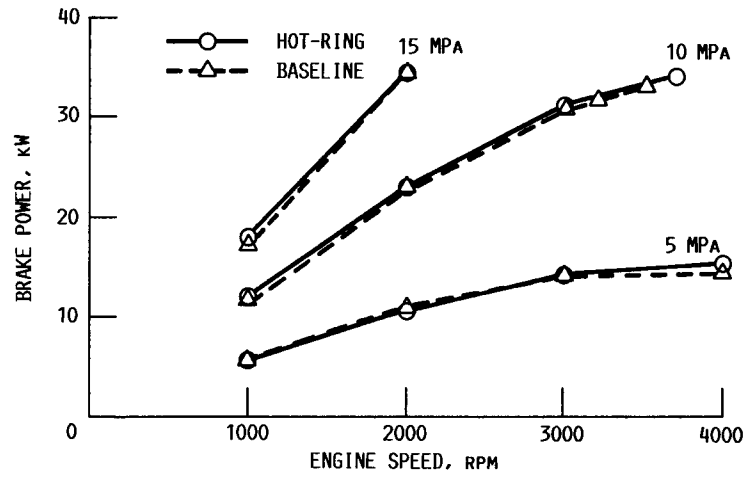
# MOD I STIRLING ENGINE

FIGURE 11. - POWER COMPARISON-HOT-RING VERSUS BASELINE.

In order to obtain a direct comparison of hot-ring performance with the standard configuration, tests were run at 5, 10, and 15 MPa over a range of engine speeds. Figure 11 shows brake power as a function of engine speeds for both configurations at all three operating pressures. Unfortunately, a malfunctioning air/fuel control system limited the maximum fuel flow available and operation was not feasible beyond about 3500 rpm at 10 MPa and 2000 rpm at 15 MPa. The hot-ring power level appears to be slightly higher (as much as 6 percent) at all operating conditions. We had hoped for more. However, we must also consider that this apparent small net gain was achieved even though total ring friction was increased with the added hot-ring. If this is accounted for, the apparent thermodynamic gain due to appendix loss reduction alone was up as much as 11 percent in power.

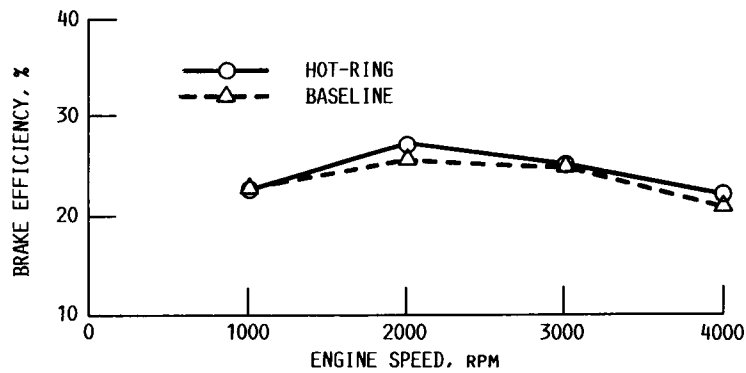
## MOD I STIRLING ENGINE; 5 MPa MEAN PRESSURE

FIGURE 12. - EFFICIENCY COMPARISON-HOT-RING VERSUS BASELINE.

Figures 12 to 14 show an efficiency comparison for the same tests. Again, as with the power, efficiency appears slightly higher for all operating conditions. Taking the added friction into account gives essentially the same results as for power--maximum apparent thermodynamic gains of 11 percent or more.

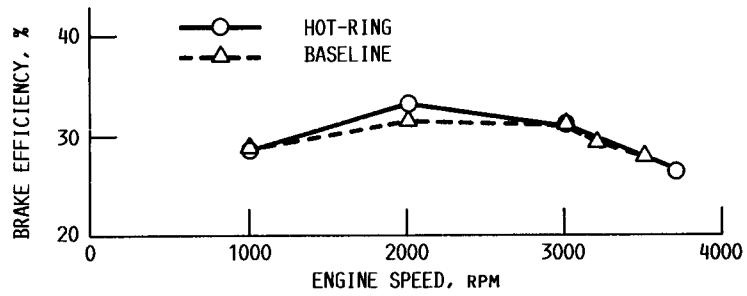
MOD I STIRLING ENGINE; 10 MPa MEAN PRESSURE

FIGURE 13. - EFFICIENCY COMPARISON-HOT-RING VERSUS BASELINE.

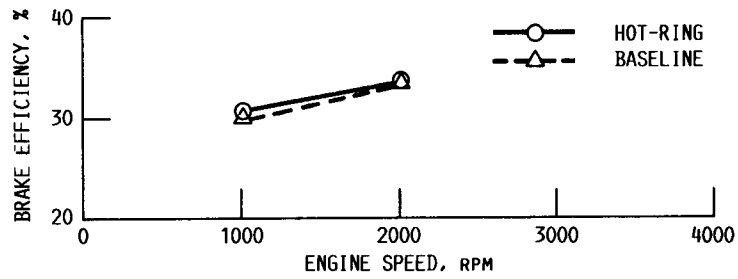
MOD I STIRLING ENGINE; 15 MPa MEAN PRESSURE

FIGURE 14. - EFFICIENCY COMPARISON-HOT-RING VERSUS BASELINE.
